Cornerstones March 2022

Fire Station #5 added to the National Register of Historic Places

Weatherizing Your Historic House

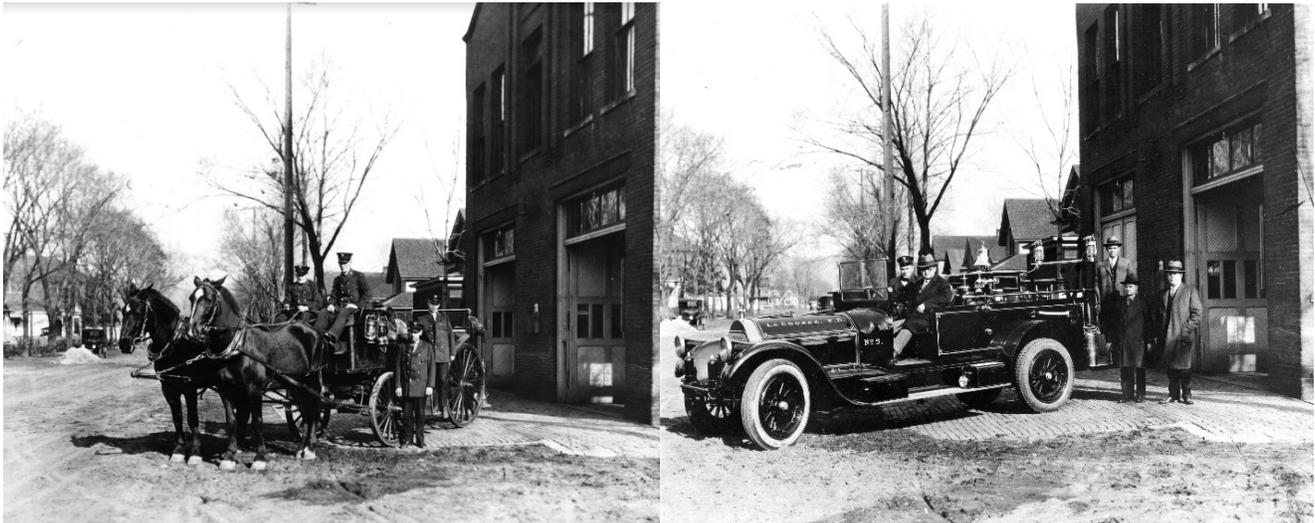
Both images: Fire Station No. 5 ca. April 14, 1926. Photos courtesy of UW-L Murphy Library Special Collections

The 2-story rectangular building features a gable roof over the primary spaces in the front, and a shed roof on the stable spaces at the rear. The structure is multi-wythe brick with a trussed roof and a unique second floor structure. Instead of cluttering the main level with columns to support the second floor, the second story floor joists are hung from the roof trusses by cast iron tie rods (Miller, sect. 7, pg. 1).

The front (north) elevation contained two large engine bay doors at street level that have since been infilled with wood framing. The apparatus bay on the north side originally contained two fire pole hatch openings, one below the former club room, the other below the former sleeping room. The rear of the apparatus bay contains the original staircase leading to second floor, complete with panelized square newel posts, turned finials, turned balusters, and hardwood treads and risers (Miller, sect. 7 pg. 4). Though the fire poles have been removed, the grand stair remains. It should be noted that the original first floor was constructed of wood framing. The floor structure was removed and replaced with a poured concrete slab and beam structure to support the heavier gasoline powered firefighting equipment.

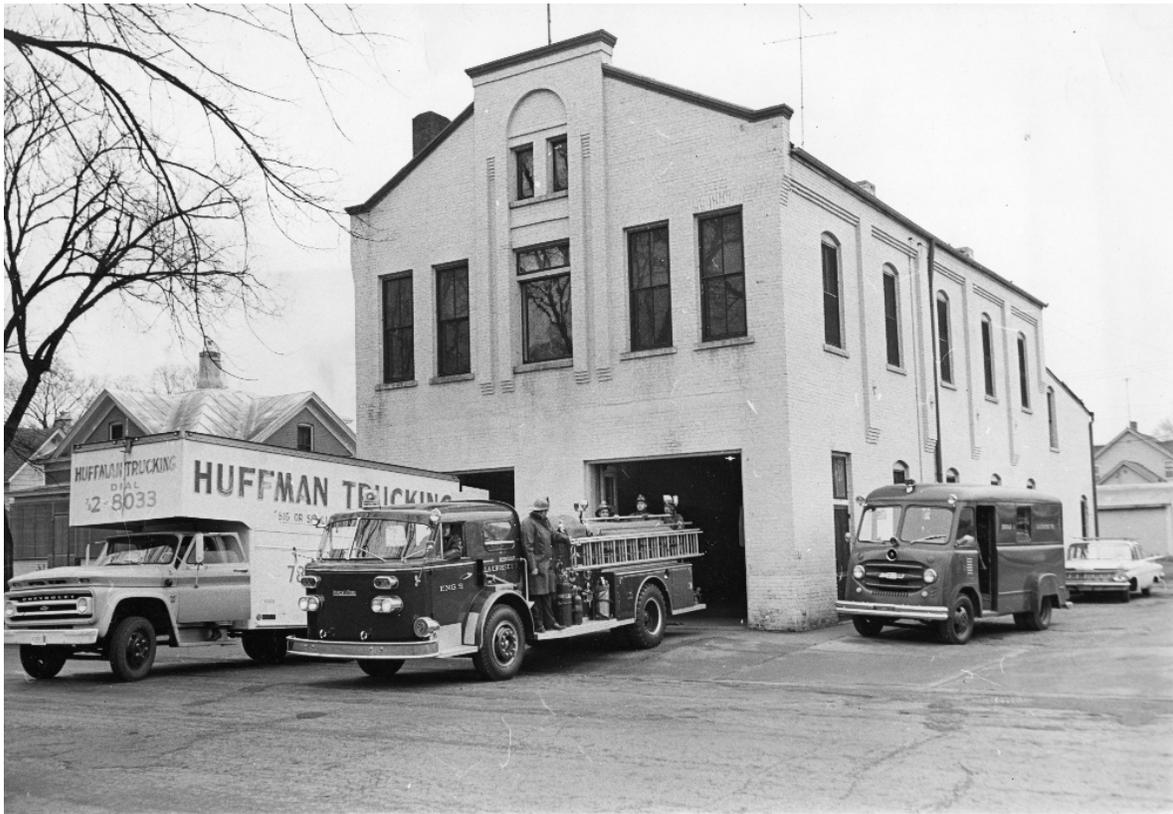
Fire Station No. 5 ca. November 22, 1967 Photo courtesy of UW-L Murphy Library Special Collections

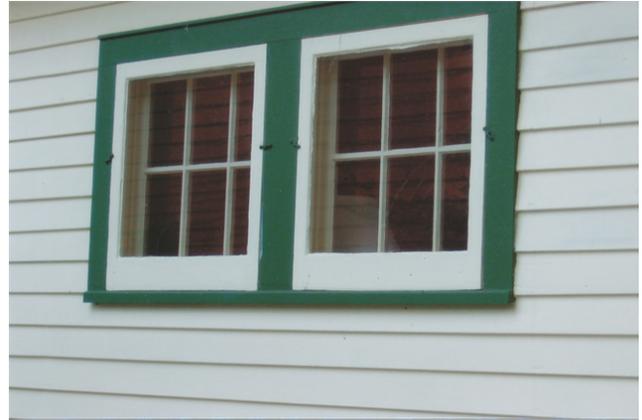
Dane County. Here you can see original wood storm windows with the turn-buckle hardware. Source: WHS - State Historic Preservation Office.

- **Caulk only the exterior edges of your electrical boxes.** Apply caulk only to the edges of electrical boxes. Do not caulk the wires or back of a metal box, which could cause heat to build up and start a fire. Do not caulk recessed light boxes.
- **Keep and weatherize your original windows.** Keep your original windows and weatherize them to improve their energy efficiency. Your original windows can be made as (or more) energy efficient than replacement windows in a cost effective manner. Do not install expensive replacement windows.
- **Keep the weep holes on your storm windows open.** Check the weep holes on the bottom edge of your aluminum storm windows regularly to be sure they are open. The weep holes allow condensation to escape. Do not caulk the weep holes on your storm windows.
